On the integrity investigation of pressure tanks through acoustic emission test

1st EPERC International Conference - Non-Destructive Examination - In Service Inspection and Operation Rome, 2nd April 2019

To verify the structural integrity of five 1000 I LGP vertical tanks with artificial defects by applying acoustic emission test according to the ISPESL procedure

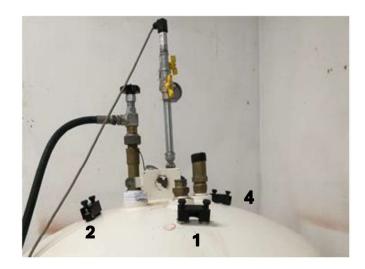
AE sensor placement

- 4 Piezoelectric sensors
- Placement following the symmetry of the tank
- Two couples of sensors spaced about 500 ± 100 mm
- Fixed with magnetic brackets

Testing three configurations:

- 4 sensors
- 2 sensors (1 e 3)
- 2 sensors (2 e 4)

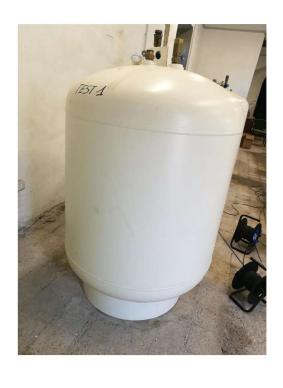
TEST1 - Tank

Test 1 - A shell's thickness reduction of 0.9 mm; no artificial defects
