# **Further Developments in Inspection and Monitoring Techniques for High Temperature Plant**

Dr Ahmed Shibli, Dr David Robertson, ETD, UK

## **P91: Manufacturing, welding heat treatment + Safe Remaining Life**

### **'P91-P92 Inspection & Lifing' .**

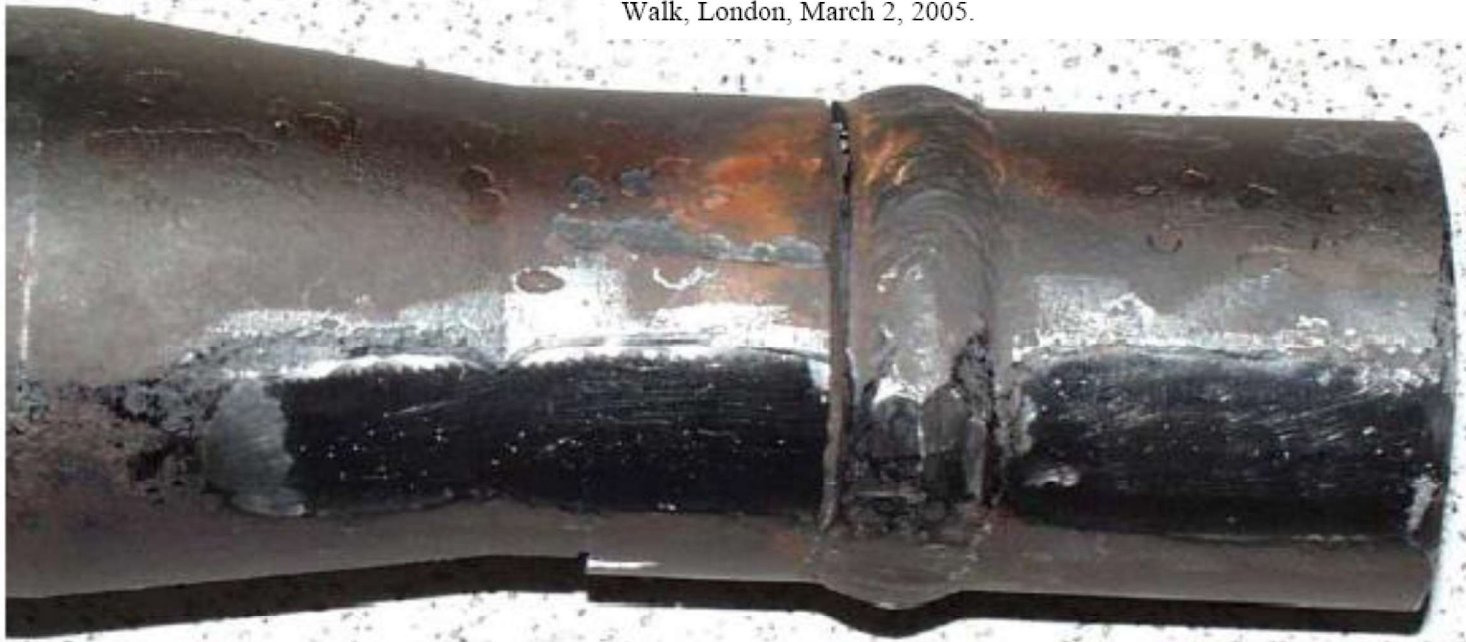
*Type IV cracking on the F91 side of a weld between an F91 forged transition bottle and a T91 tube (48mm OD) taken from Ref [2].*

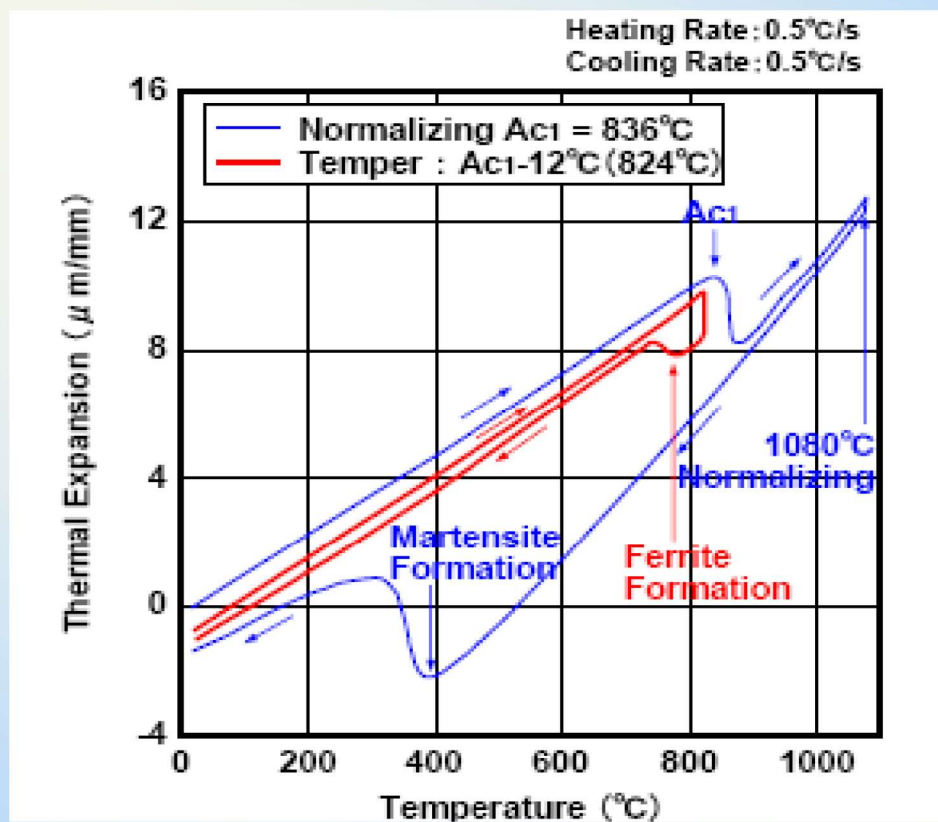
# Dilatometric measurement of P91

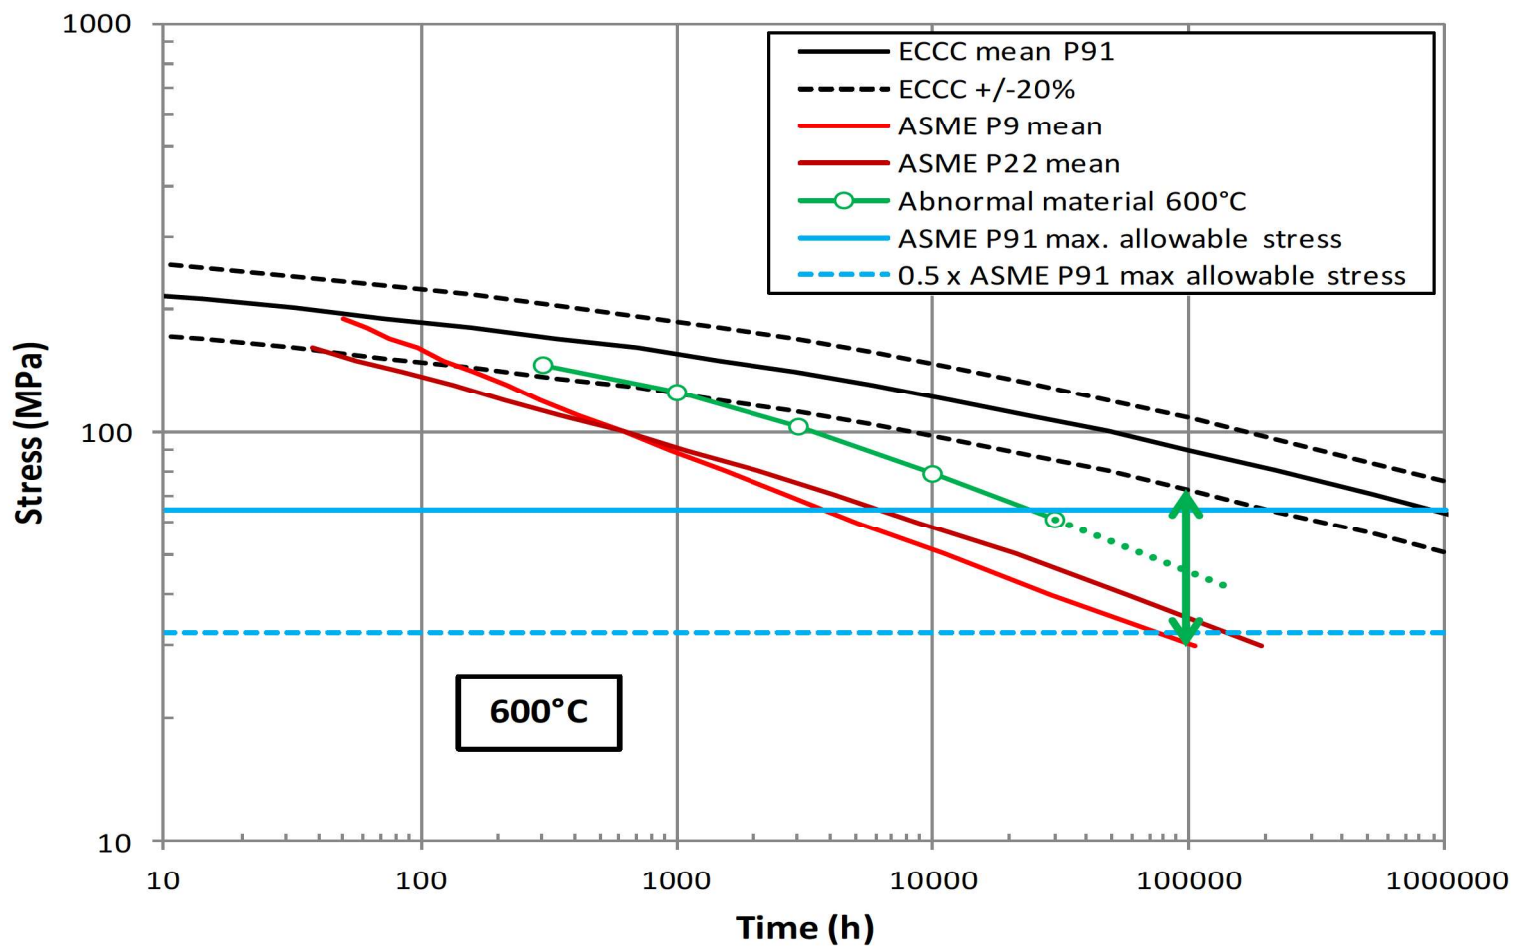
## 'Aberrant' P91 (green line) may lie between P91 and low alloy bainitic steel strength

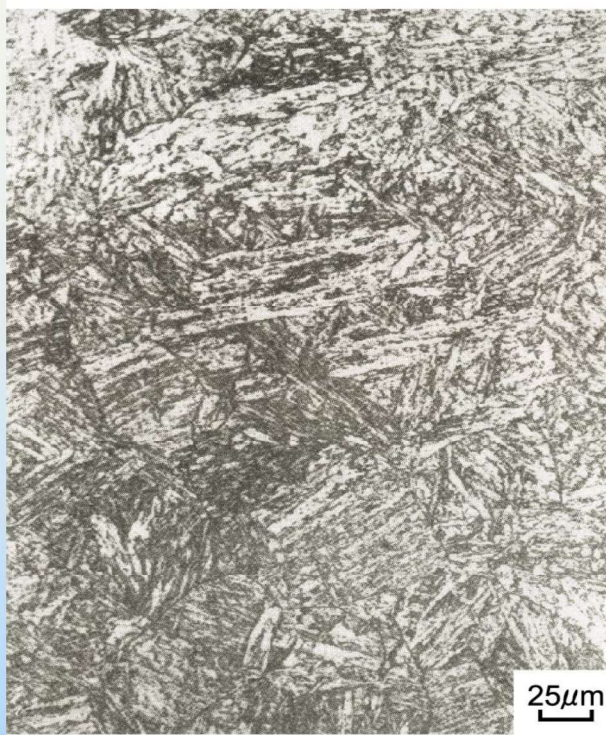
## Typical Microstructure of Martensitic 9-12%Cr Steel (Matrix, Precipitates, Dislocation structures)

a) OM

b) TEM

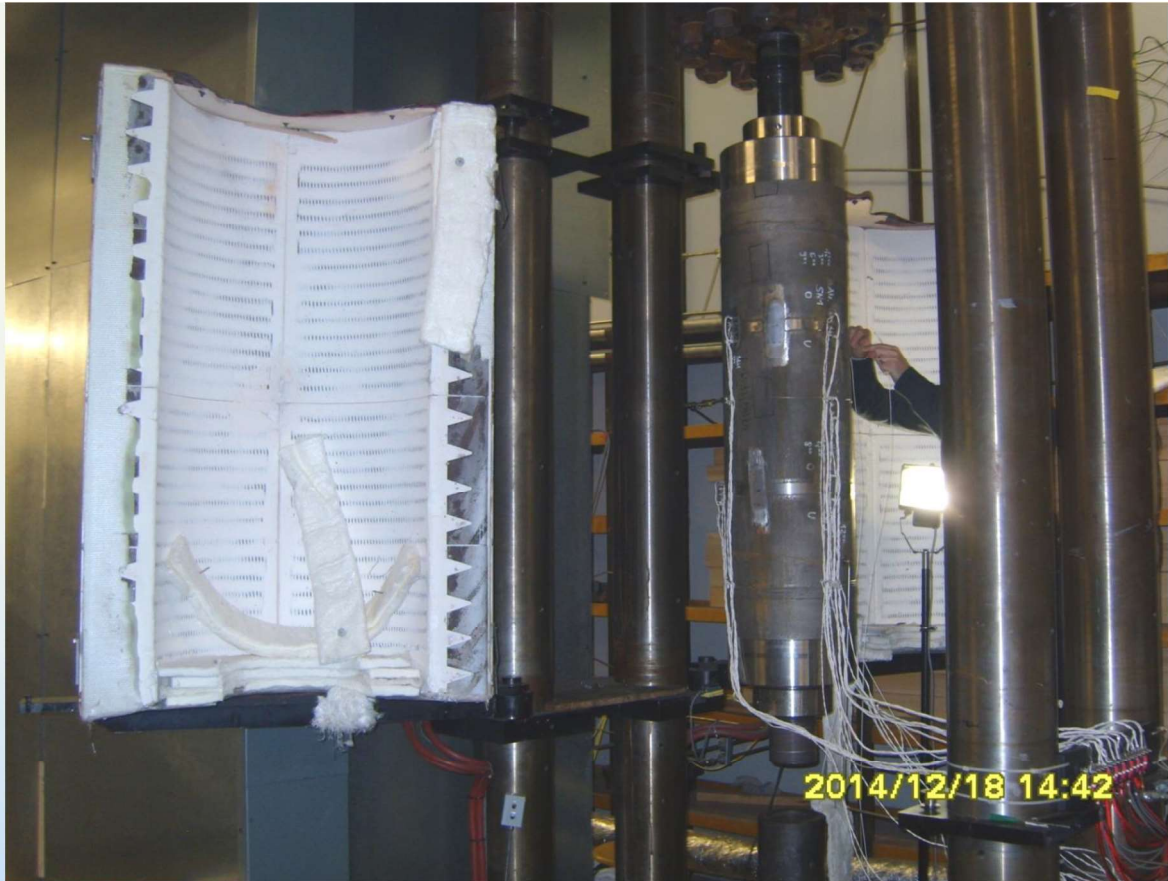
**P91 pipe with two butt welds being tested at temperature, under pressure and end load to simulate system loads**

- Testing of these feature specimens was stopped at ~**30, 50, and 70%** of the estimated life of **10kh** at 600 and 625C.
- **New NDE** techniques were developed and used to quantify damage & relate to remaining life. **FE analysis** was performed to develop RLA relationships.
- **'Slice samples'** using EDSE were cut out from some of the test welds during the outages to relate damage detected by the NDE techniques to the real damage.

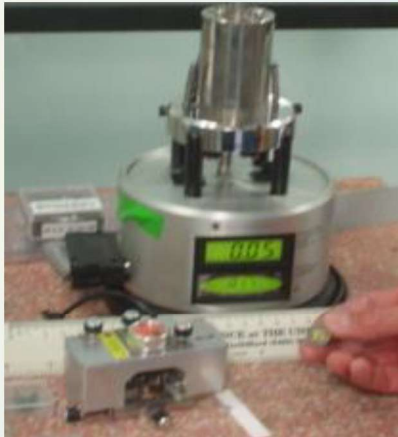
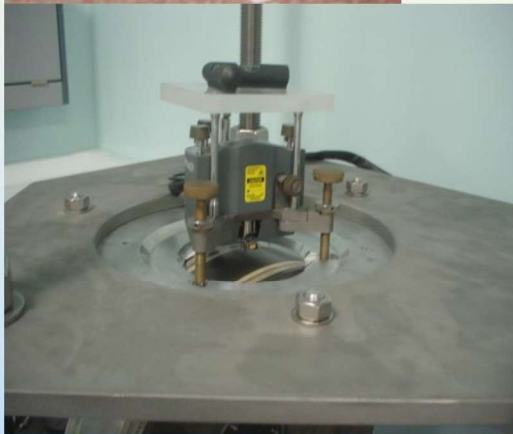
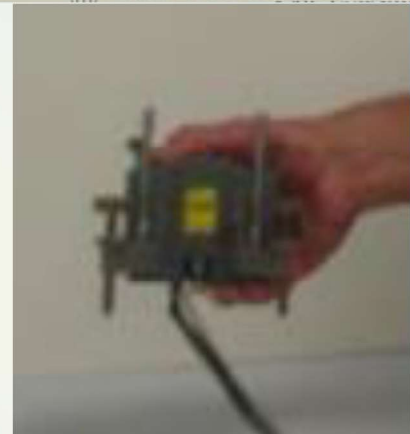
**Scanning Force Microscope.** From top left hand (clockwise) – Lab version, portable version, portable version hand held, Portable version in use on a pipe ring

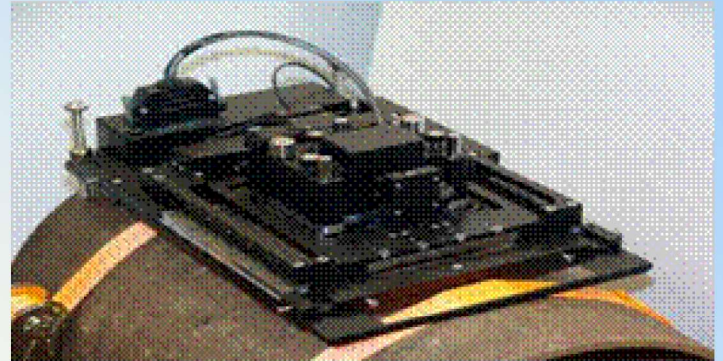
**New SFM with the mounting frame. Clockwise from top left: Schematic with the mounting frame, SFM mounted on a horizontal pipe, SFM enclosed in a box for safe keeping in plant during use, SFM mounted on a vertical pipe**

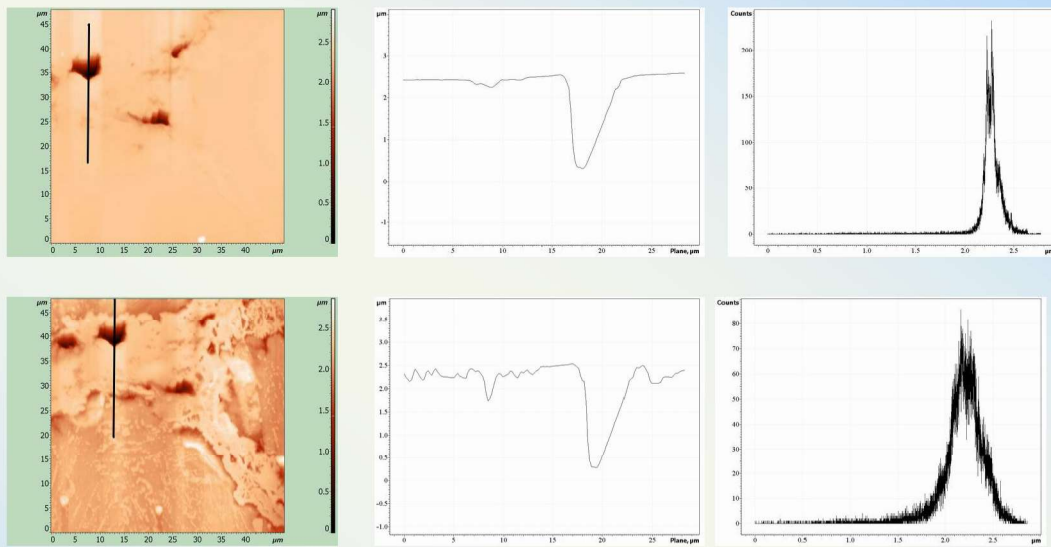
Figure.12. SFM images acquired before and after chemical etching for 2 minutes. Height data and depth distribution curves are shown at the right side. Increase of the half-width after etching is determined by surface roughening during etching

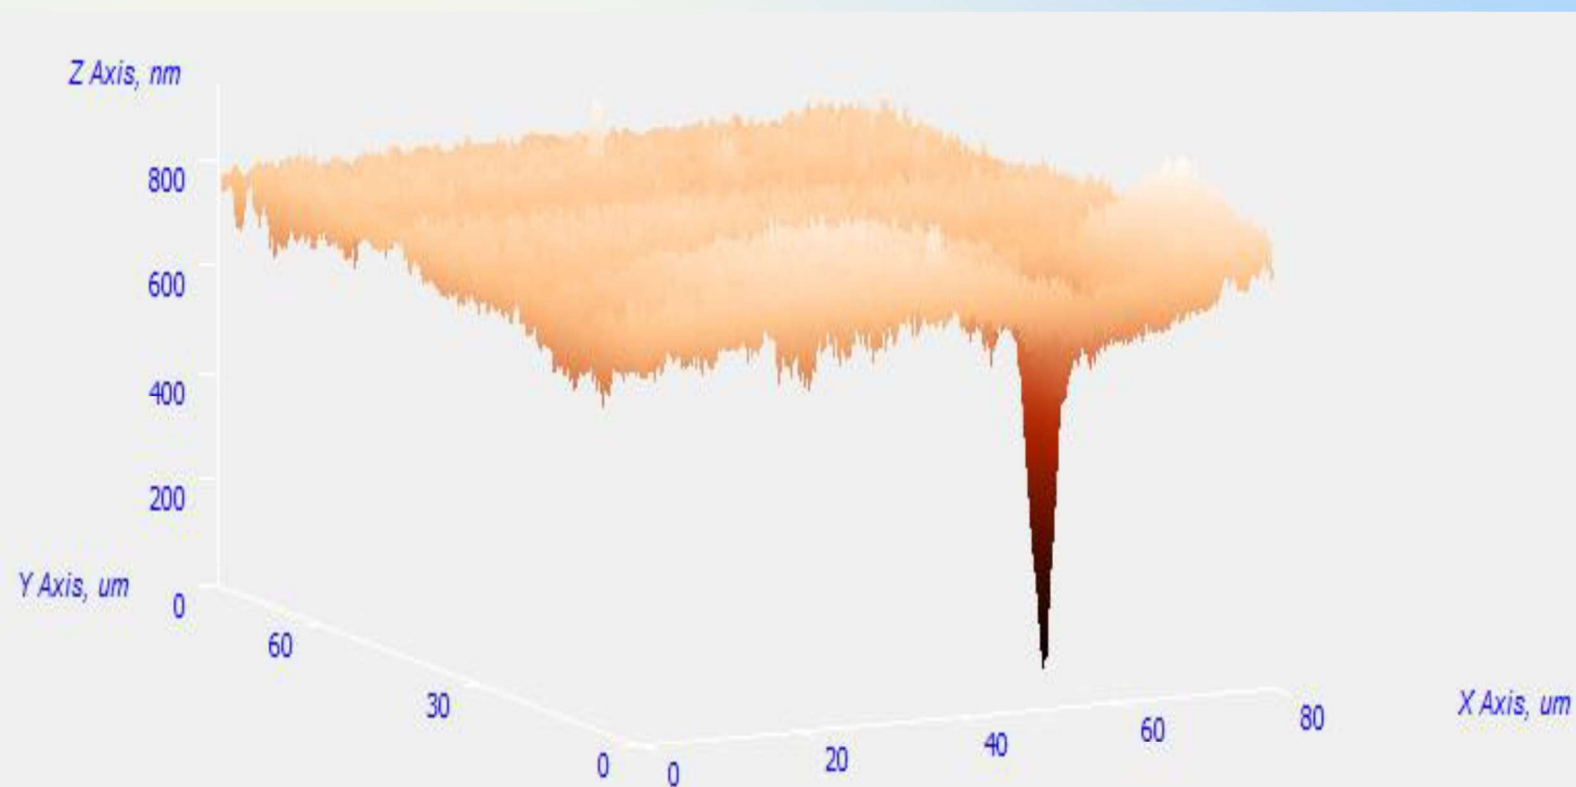
## Three dimensional SFM image of the P91 pipe showing the cavity depth

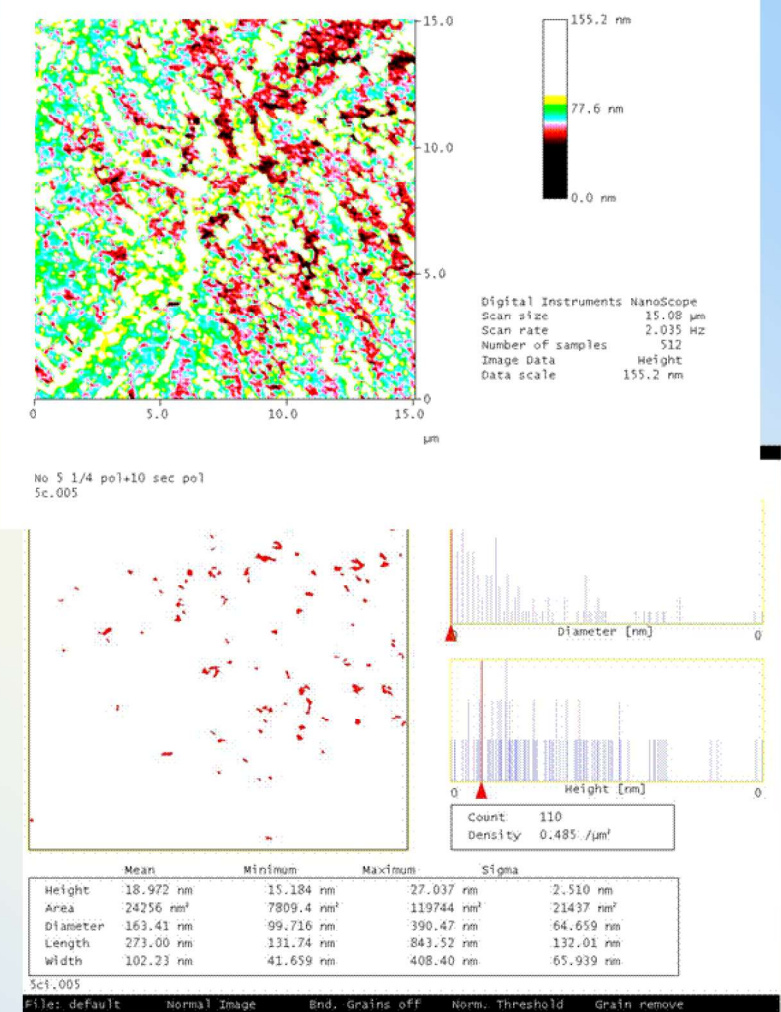
Creep specimen tested at 625C and interrupted at 18% of life

Top: SFM cavity micrograph (black spots are the deep cavities)

Bottom: Footprint of the cavities

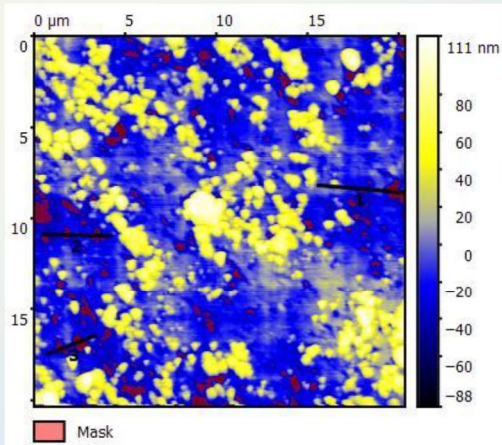
### CAVITIES

Total projected area (abs.):  $14.4 \mu\text{m}^2$   
 Total projected area (rel.): 3.48 %  
 Total cavities volume (zero):  $0.82 \mu\text{m}^3$

### PRECIPITATES

Total projected area (abs.):  $61 \mu\text{m}^2$   
 Total projected area (rel.): 14.79 %  
 Total grain volume (zero):  $3.7 \mu\text{m}^3$

SFM results for a Steam Pipe after a Service of 100kh at  
 $\sim 580\text{C}$

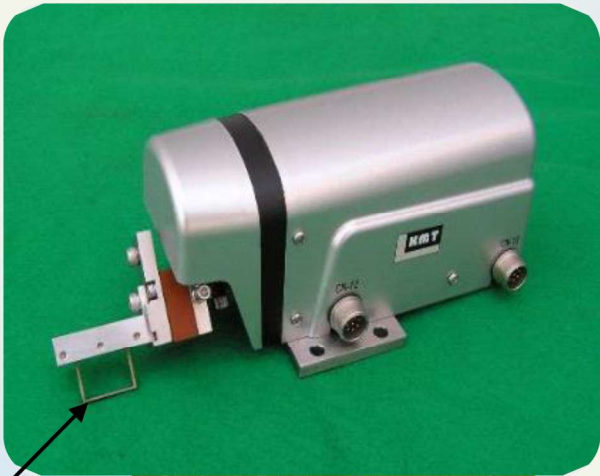
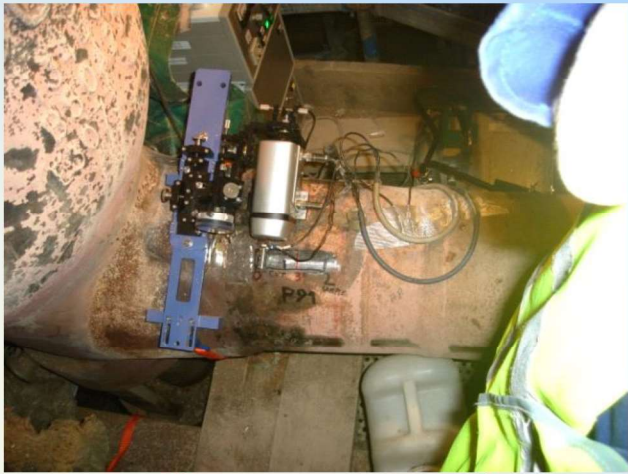
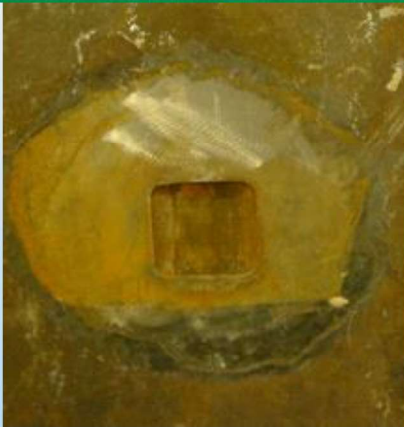
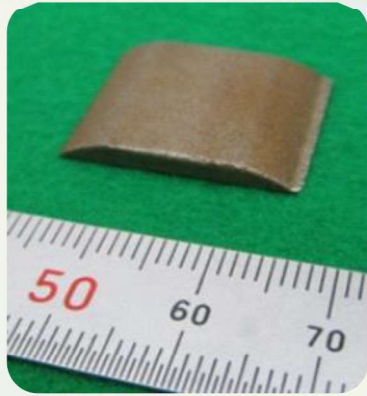
*From top left (clockwise):* **EDSE cutting a sample from the reducer pipe; 4mm thick piece cut out from the pipe; round edge cavity left behind**

*Cutting electrode*

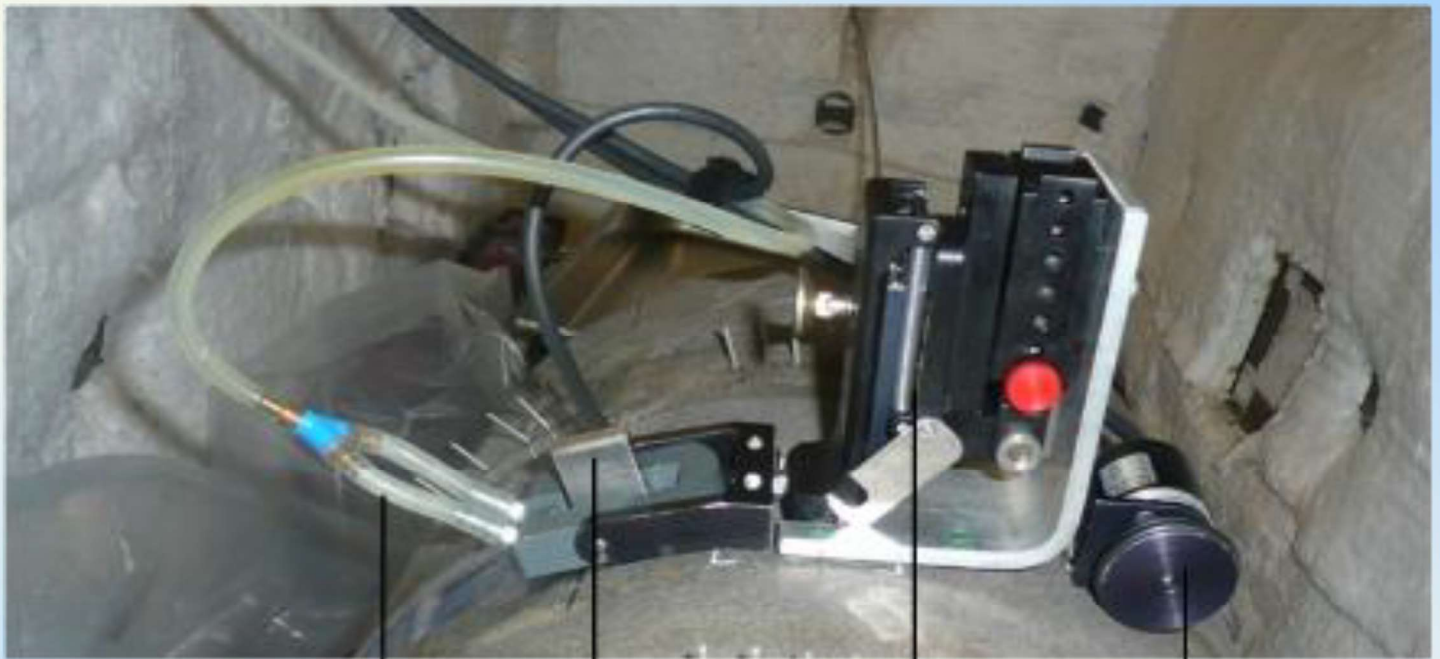
## UT backscatter inspection tool

Couplant supply

Ultrasonic phased array probe

Position encoder

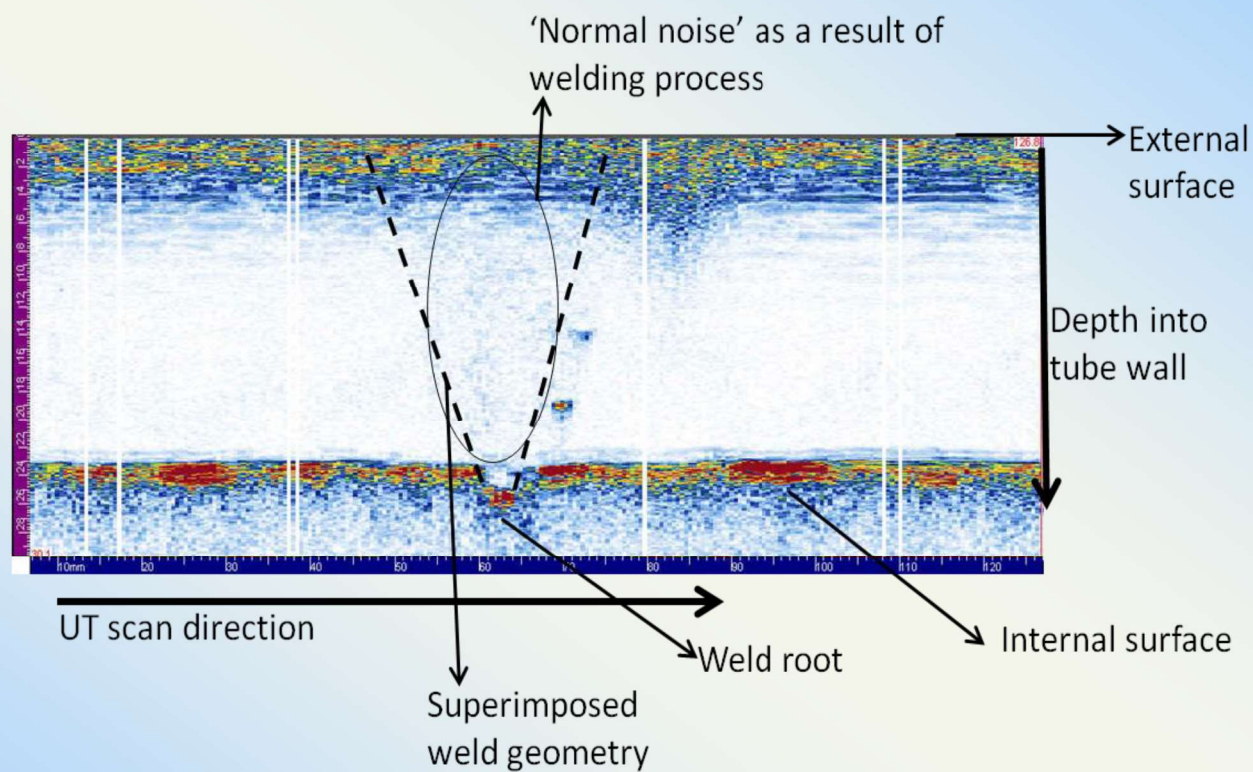
UT Back Scattering Method for Damage Detection and Quantification in a P91 welded pipe (*two spots on the right hand side of the weld show the early stage damage development – at 30% of the calculated life*)

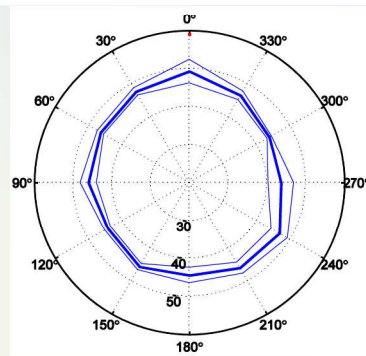
# UT Velocity Ratio/Change Method

(a) tube A - attenuation

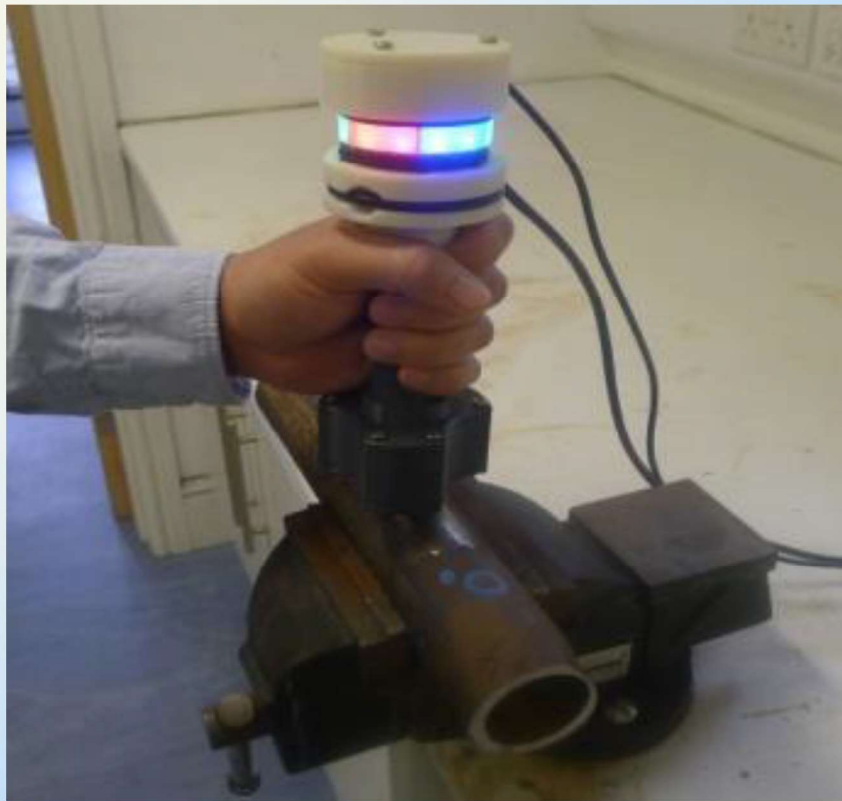
# SMART SLEEVE: New Portable Precision Hardness Tester
