1st EPERC International Conference, Rome 1-3 April 2019

Elisa Pichini, Daniela Lega, Claudio Andenna, Vincenzo Munaron

Ageing of high density polyethylene piping

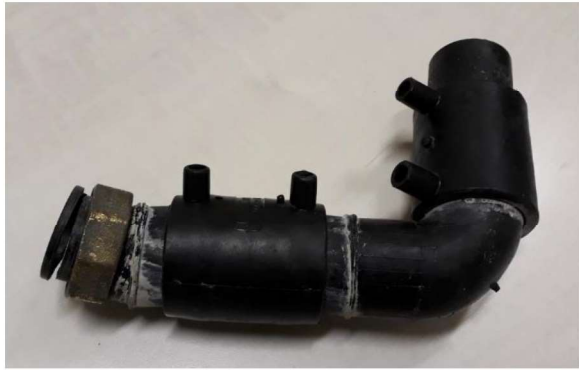
The drain tube of my shower

The brittle fracture occurred after no more than 20 years of use

A very little piece
but I had to spend 500 euros to replace it and to paint the ceiling of the apartment below

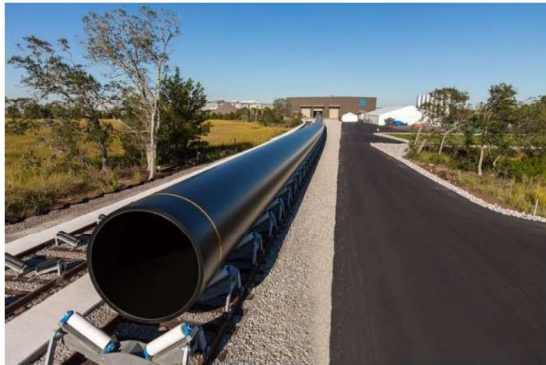
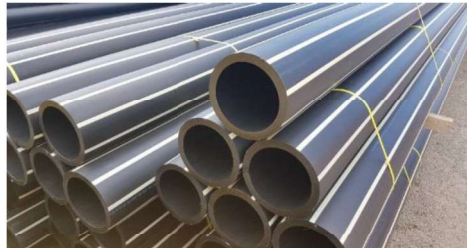
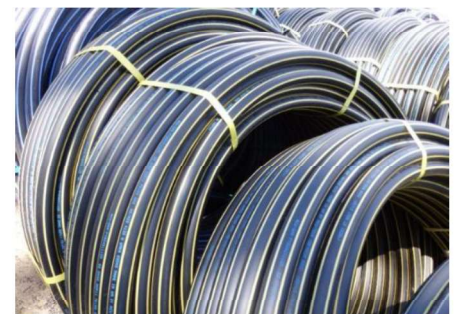
Pipes in high-density polyethylene piping: Types

Black no Stripes – For all applications except for fuel gasses

Black with Cream Stripes – Sewer Pipes

Black with Yellow Stripes or Full Yellow Jacket –
Fuel gases, process gases, liquefied gases under pressure

Black with Blue Stripes – Drinking/potable water

Black with Lilac o Purple Stripes – Recycled or reclaimed water

Black with Red Stripes – Water dedicated for fire extinguishing supply lines

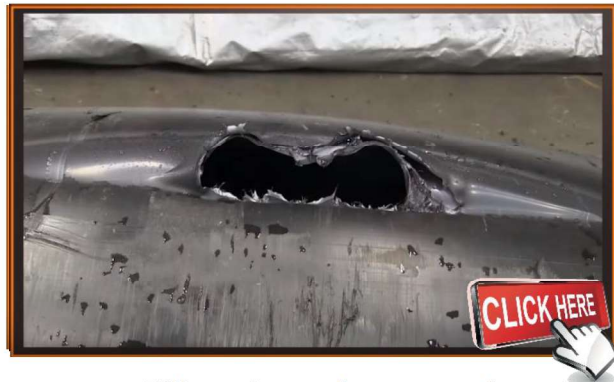
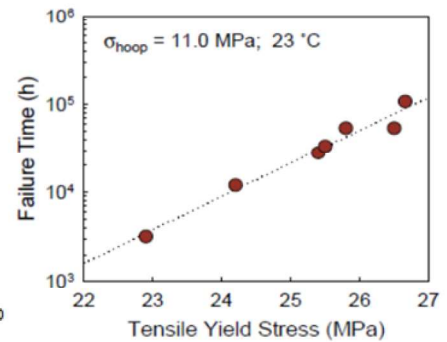
In the 1th stage if the pipe is subjected to mechanical overload, the material fails due to ductile yielding

Filling pipes of water and putting them in pressure till they break, it can be seen that: the higher is the crystallinity percentage of the HDPE used ->

-> the higher is the value of the Yield stress of the pipe

Fixing the pressure inside the pipes at values that overload the material, it can be seen that: the higher is the Yield stress of the HDPE used ->

-> the higher is the time to fail of the pipe

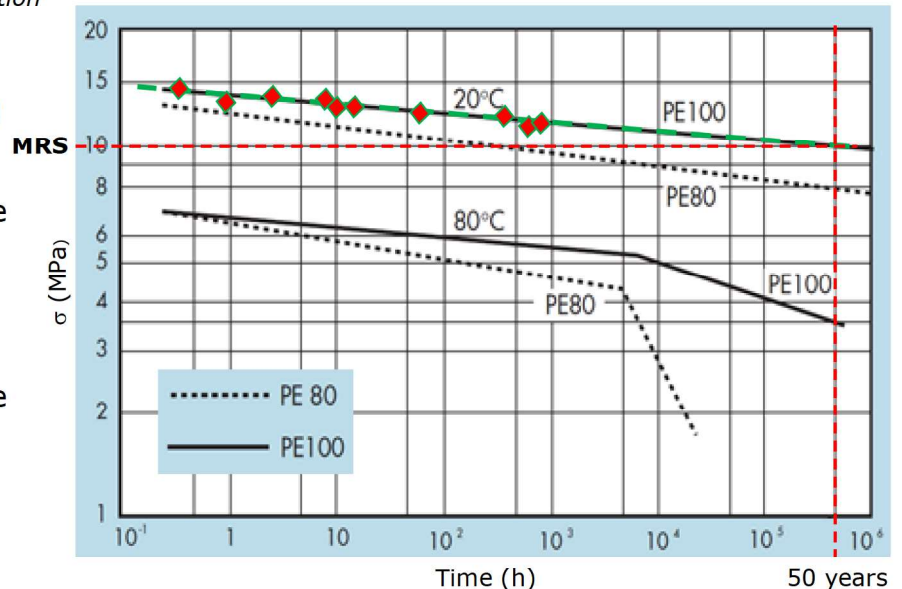
Performing hydrostatic tests until failure or not less then 9000 hr

in accordance with ISO 9080 'Plastic pipe and ducting systems - Determination of long term hydrostatic strength of thermoplastic materials in pipe form by extrapolation'

and extrapolating the measured curve
it can be determined
the **Minimum Required Strength (MRS)**
that can be thought as the load
– due to pure internal pressure –
that would cause the pipe ductile failure
after 50 years of service at 20 °C

If the tests are performed
at temperatures higher than 20 °C
the curves are lower and show a knee
followed by a faster descent long before
than the 50 years of service:

this is the so called 'mechanical knee'
and indicates that the HDPE begins
to mechanically react to the load
in a different way

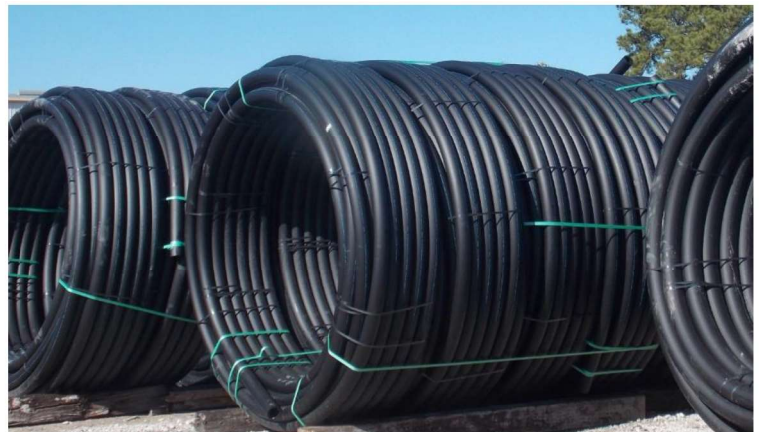
For problems of encumbrance
the pipes are left outdoor, exposed to the sun,
to the rain, to thermal changes

**all inappropriate weather conditions
that may result in leaching or
consumption of additives**

and the leaching or the consumption
of additives may result in pipes
with an ageing already in place and
in an ageing resistance in the years of service
other than the presumed ones

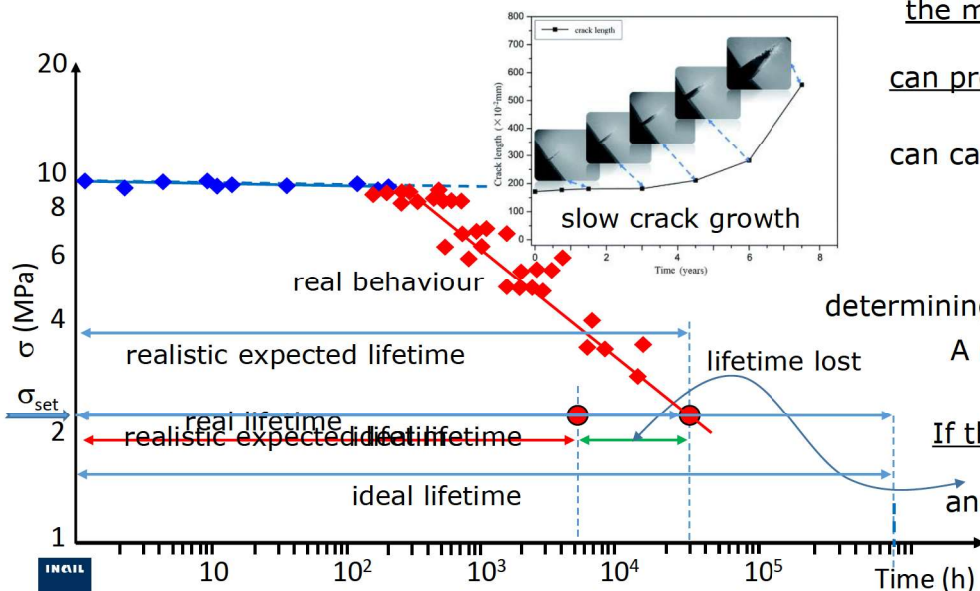
Let's suppose to bury a new pipe: on the basis of its MRS and its SCG resistance we set the pressure inside to have a long lifetime

During the handling, the transport and the undergrounding, the machines with which the pipe is seized, moved, loaded, unloaded, buried can provide carvings or cracks on its surface

Also landslides of the ground can cause cracks and/or tensions in the pipe

In correspondence of the cracks tensions can concentrate until the critical stress is exceeded, determining the growth of the cracks themselves

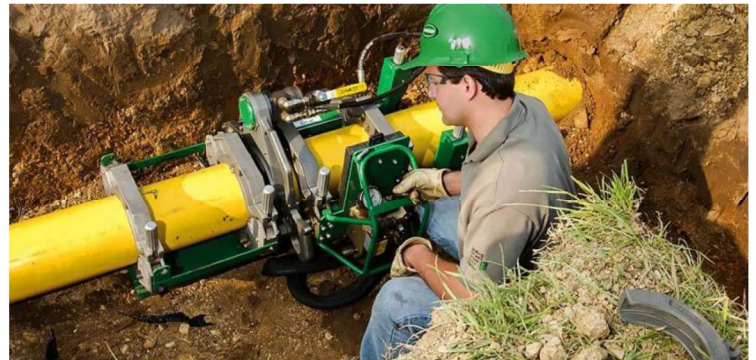
Further critical issues are the thermoweld joints: however well standardized at international level, joints can be the seat of

- particles in the molten material - due to contaminations with the surrounding environment – that compromise the fusion integrity and can act as stress concentration sites, the precursors to SCG
- residual tensions – bending and torsion – when the welds join the extremes of tubes products in rolls

Therefore, **the thermoweld joints are often covered directly by the ground and forgotten**
